Colyford Interim Conservation Area Review

COLYFORD

Prepared for East Devon District Council by John Fisher BA, MA, MRTPI
with contributions from Town and Parish Councils and Amenity Societies in East Devon

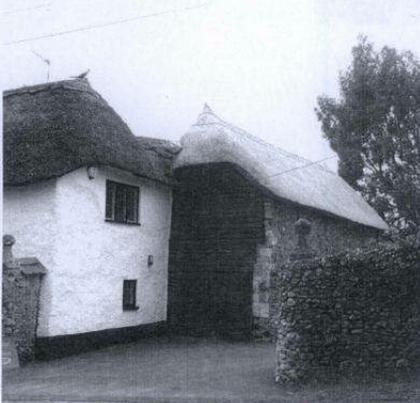
Recent re-thatching of a prominent barn in Colyford.

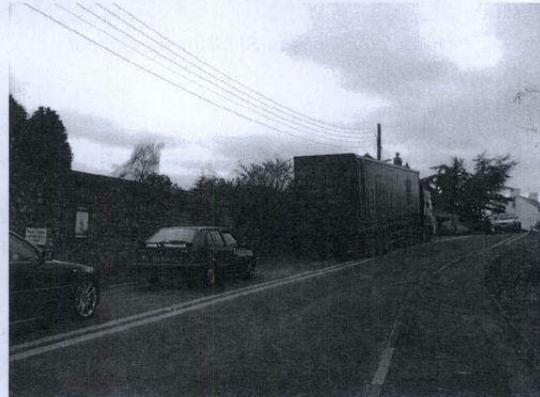
An increase in through traffic has the effect of dividing the southern and northern halves of the village.

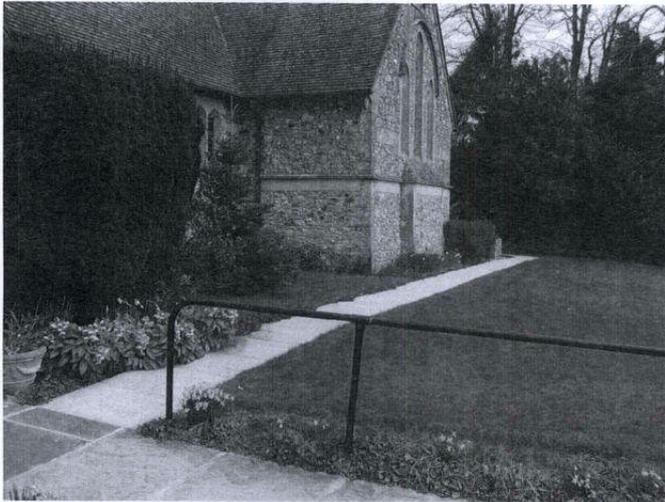
- Unfortunately PVCu windows have been installed in some key buildings through the conservation area. The cumulative impact of unsympathetic replacement windows has compromised the character and appearance of the village.
- The Chapel has had disabled access made by adding crude pipe railings to front path. These detract from the front entrance to the Chapel and from the gateway.
- There are listed buildings in the conservation area identified on the Buildings at Risk Register that are still in poor condition some years after the Listed Building survey reported this.

Utilitarian railings at St Michael's Chapel.

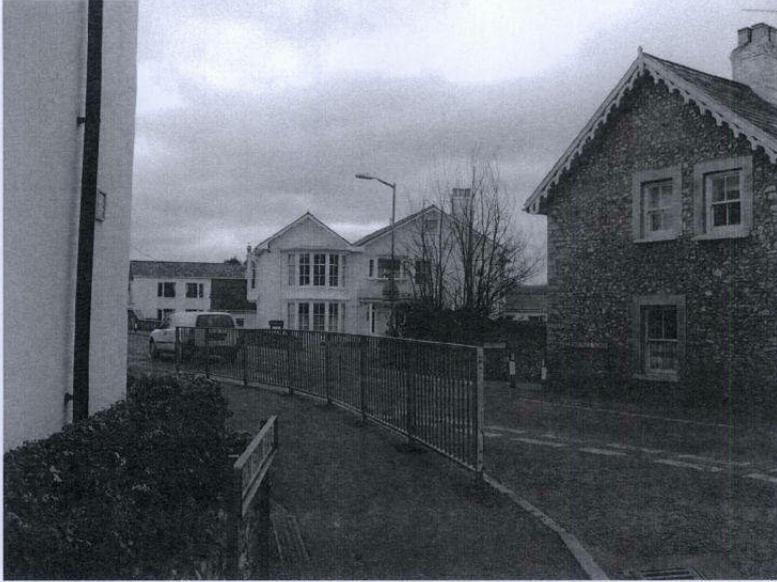
- Increase in signage at Coly Road junction is resulting in a mess of posts, bins, signs and seat on a prominent corner.
- Over-zealous health and safety compliance on new highways and developments have had a marked negative impact upon the conservation area. These include wide visibility splays,

Over-engineered new road junction on Elm Farm Lane.

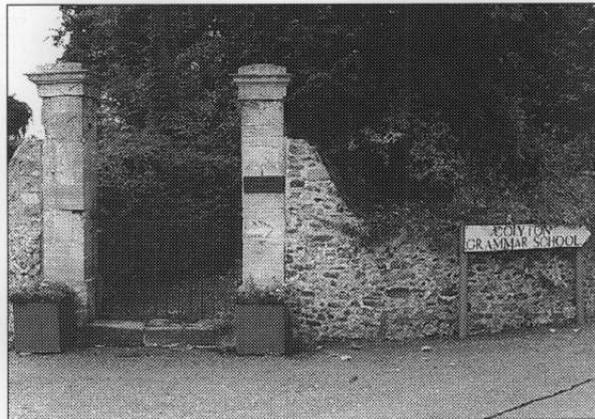
5.3 Ornament is mainly confined to 18th/19th century classical detail in porches, gate piers and iron gates; there being a particularly fine example at a former entrance to the Manor House, but now showing definite signs of deterioration. In cottages there is a generally good survival of windows with narrow glazing bars and doors using traditional joinery methods.

An original entrance to Coly House with gate piers of ashlar'd Beer stone, but now the entrance to a small wooded open space known as 'Hilary's Garden'.

- the proposed prominent development site within the curtilage of the Manor House and fronting the main street close to the centre where some of the finest specimen trees within the village are situated. It should be possible to ensure that the gate piers and iron gates are retained and restored from their present somewhat neglected state.

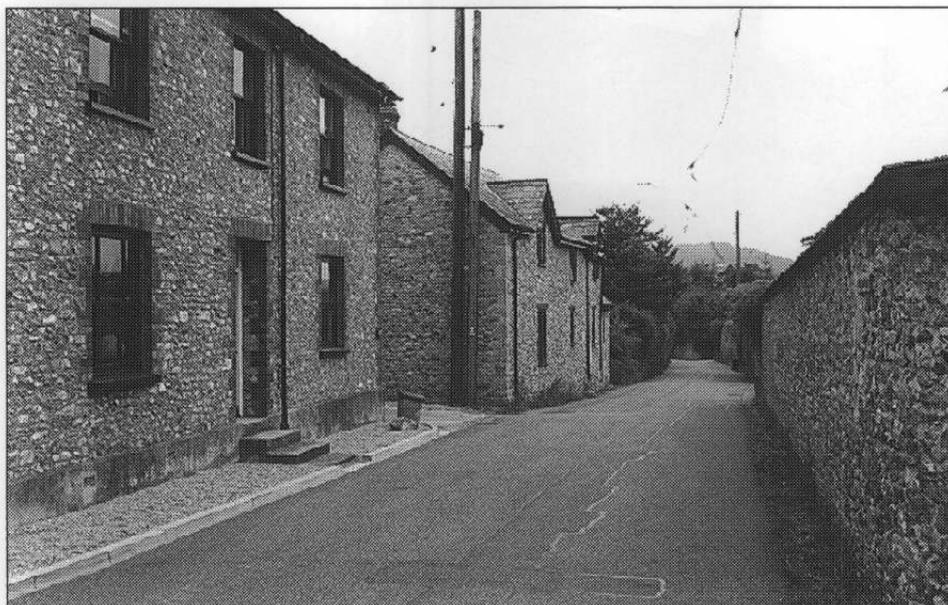
A generally well executed conversion of a former group of agricultural buildings. Dark-stained timber is said to be more durable and maintenance free than the more traditional use of white paint, but often looks visually incongruous.
